**IN THE UNITED STATES DISTRICT COURT
FOR THE MIDDLE DISTRICT OF TENNESSEE
NASHVILLE DIVISION**

DEVELOPERS DIVERSIFIED OF)	
TENNESSEE, INC., n/k/a DDR CORP.,)	
)	
Plaintiff,)	
)	
v.)	Case No. 3:04-cv-00015
)	Judge Knowles
TOKIO MARINE & FIRE)	
INSURANCE CO.,)	
)	
Defendant.)

FINDINGS OF FACT AND CONCLUSIONS OF LAW

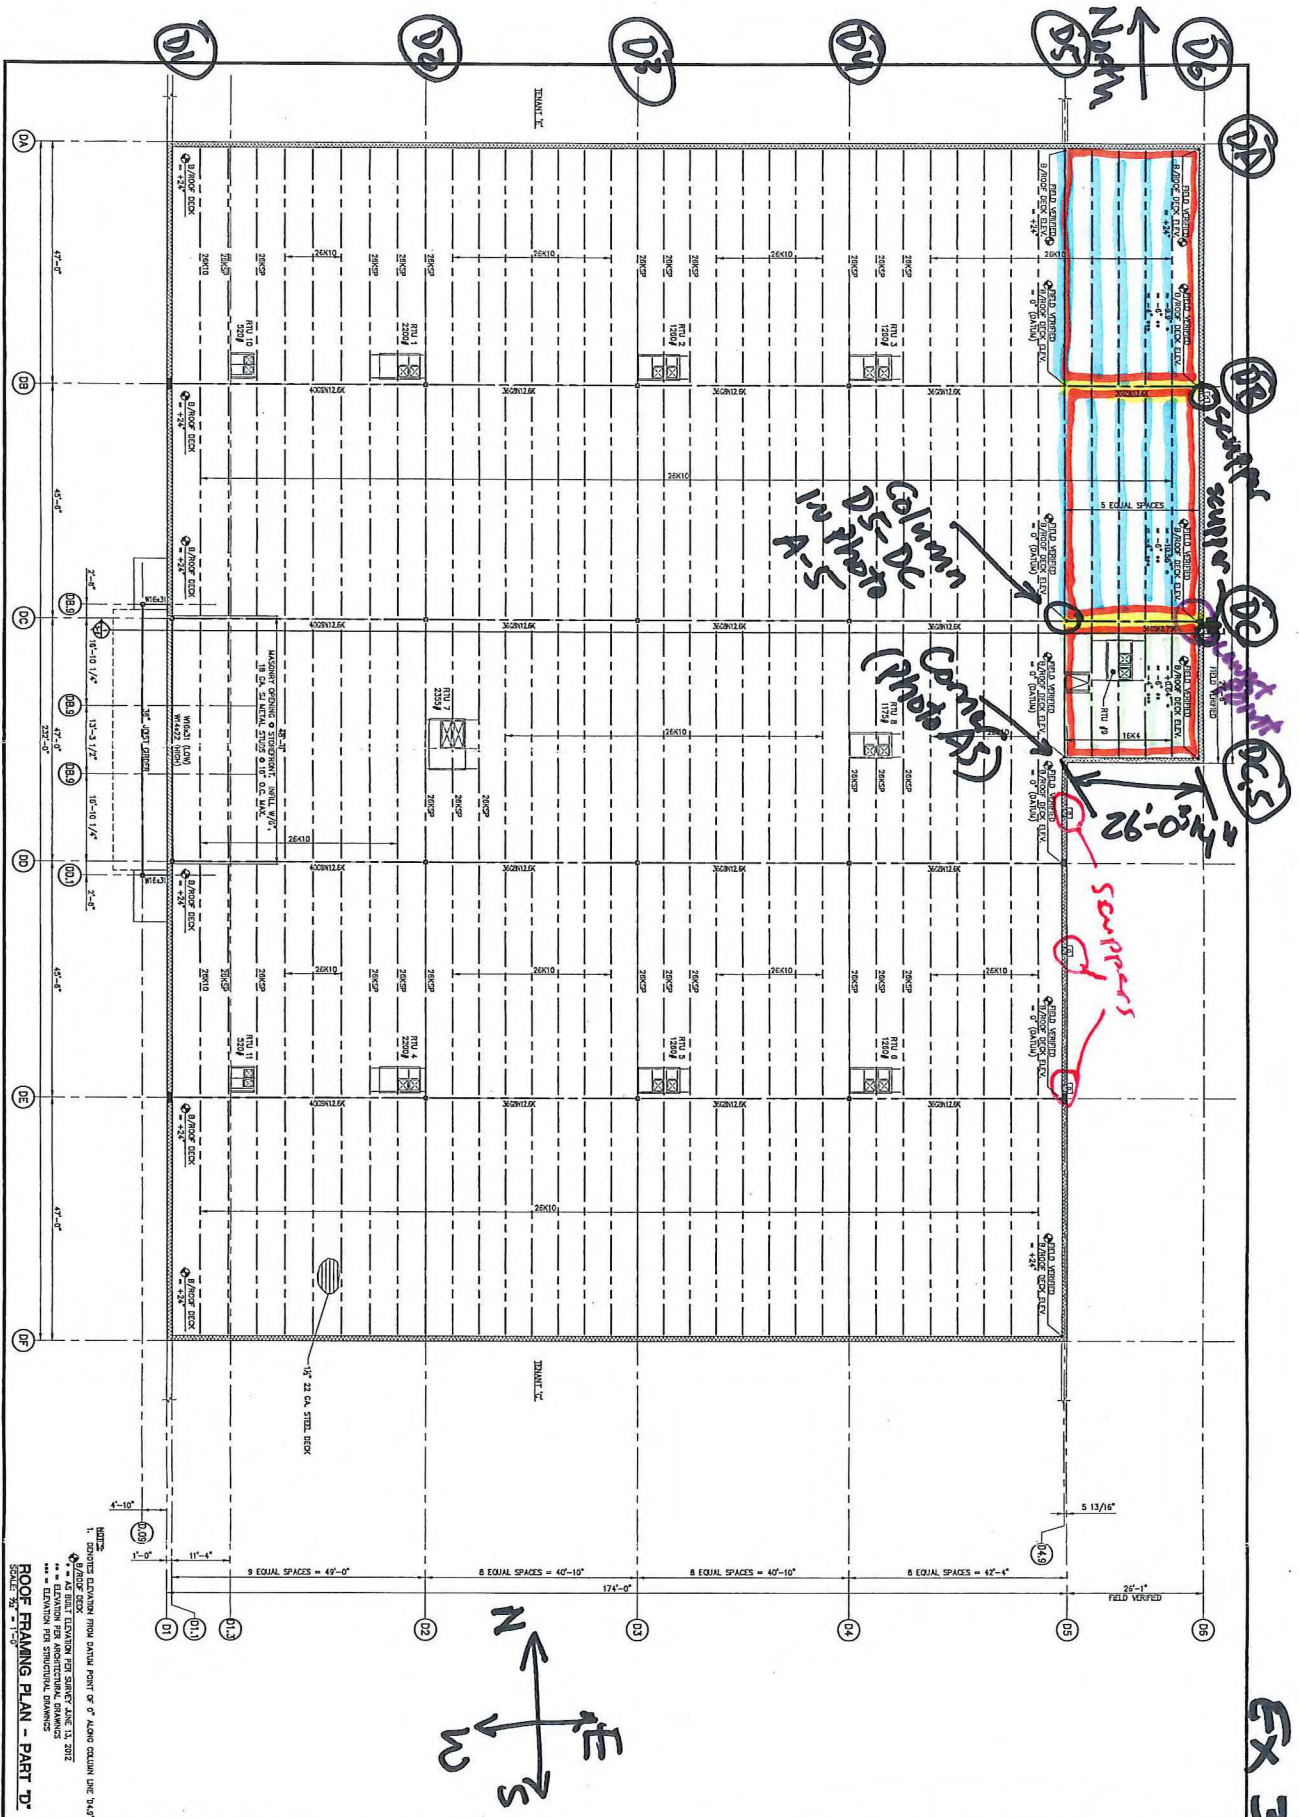
Roof Framing Plan - Part 1

Mr. Wright determined that the joist girder on line DB survived the event, but the joist girder on DC was on the ground and it "was involved in the collapse." *Id.* at 142-43. During his site visit in June 2003, he observed, among other things, the ballast retainer bars in front of the scuppers. He referred to these as "unusual." *Id.* at 154. He observed that the collapse was at the lowest point of the roof, which led him to believe that that was where the water on the roof would tend to migrate. *Id.* at 155. He thought both the DC wall and the south wall were in good shape, and there were no signs of distress in either wall. *Id.* at 156. He also referred to the "metal fabrications" in front of the scuppers as "not a typical application" Docket No. 376, p. 159. He concluded that, in general, the building was very similar to the way it was designed with some exceptions. *Id.* at 163. The architectural drawings had shown three scuppers through

Mr. Wright determined that the east end of the joist girder on line DC was inserted into the joist girder pocket on wall D6 approximately nine inches. *Id.* at 74. He stated, “the end of this girder, if you looked at this, you could not see 9.06 inches of the girder because it would be inside the wall.” *Id.* at 75. He did a design check to make sure that there were no deficiencies in the construction of the masonry wall itself, and he found none. Docket No. 377, p. 75-76. The part of the joist girder that was inserted into the wall approximately nine inches would have sat on a steel plate. *Id.* at 77.

I do believe this damage was caused by the failure of the joist girder on line DC that allowed the joist between line DB and DC and the joist between DC and D5 and all of the things that they supported, including the rooftop unit, the roof hatch, the roofing, and the ballast, to collapse into that hole.

Id. at 164. He further testified that the failure was caused by “an excessive accumulation of rain water.” *Id.* at 165. His opinion was that the failure mechanism on the joist girder was most probably a “flexural torsional buckling failure of the top cord of the joist girder on line DC from column line D5 to D6.” *Id.* at 166.
